## Inspectify Condition Report

| Manufacturer: | Ford |
| Model: | Bantam |

| Stock Number: | 8E1D00853 |

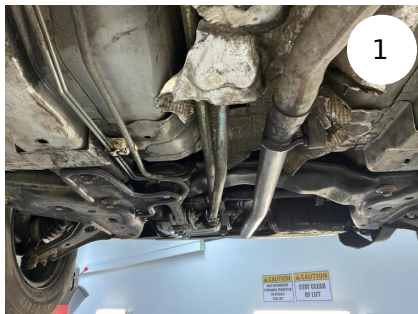
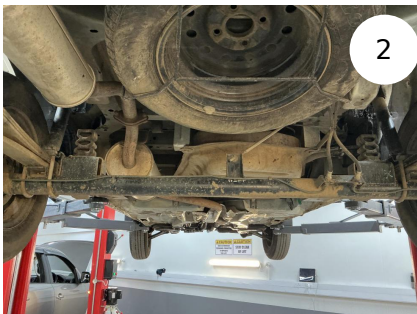
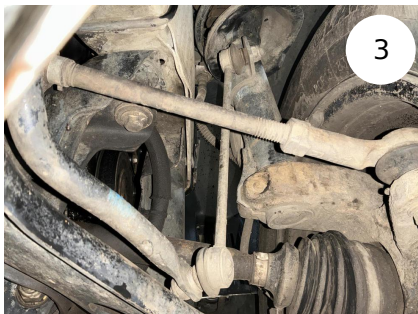
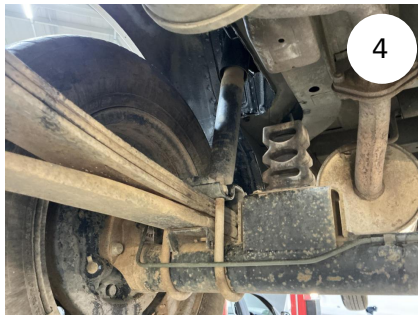
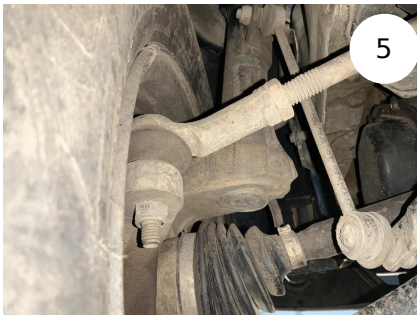
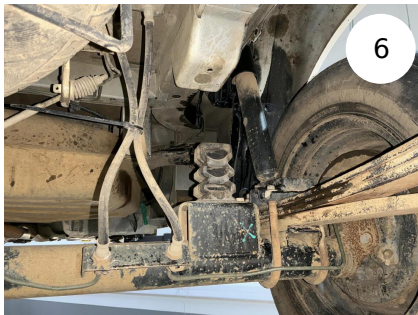
The vehicle's drive system appears well-maintained with most components in good condition, including the chassis, underbody, suspension, axles, steering, transmission, and cooling systems. However, the shocks are noted as poor and will require repair to ensure optimal ride quality and safety. All observable mechanical parts are functioning as expected, but addressing the suspension issue will be important for roadworthiness and driving comfort. Overall, the vehicle shows promise with some repairs needed for a smooth and safe drive.

| Component | Current Condition | Explanation | Roadworthy Relevant |
|---|---|---|---|
| Shocks | Poor | Suspension is faulty, leaking, or compromised. Repair is needed. | <b>X</b> |

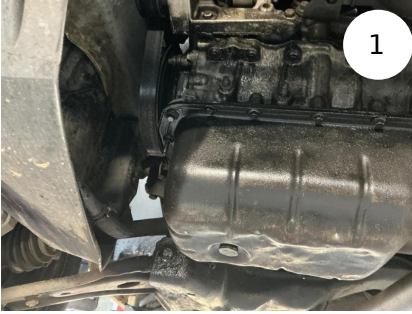
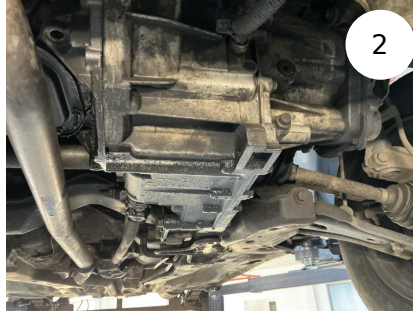
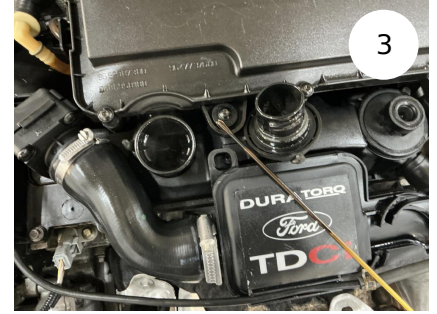
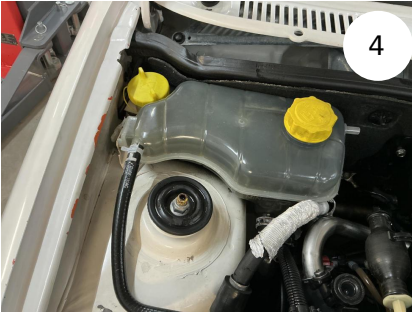
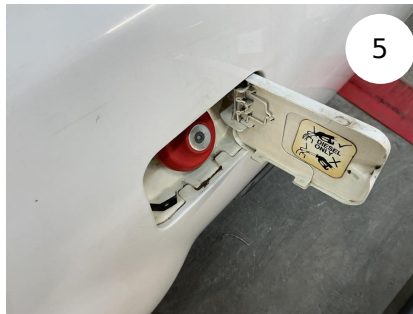
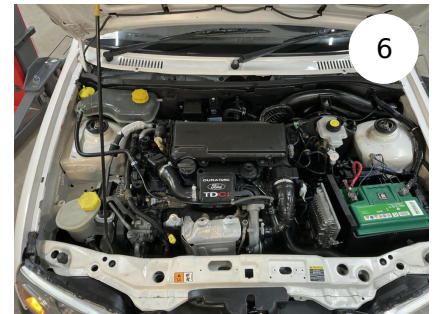
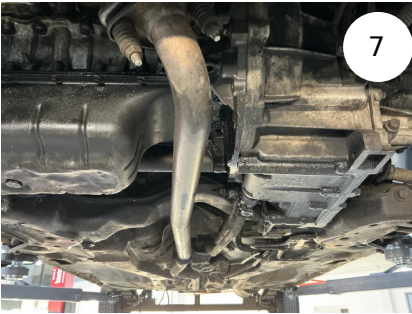
The engine compartment appears well-maintained with all observable components in good condition. Belts, hoses, wiring, and coils are intact and secure, with no visible damage. The coolant, oil, and brake fluid levels are all at proper levels, indicating good routine care. The alternator, fan, and valve train are functioning correctly. However, some minor attention to the overall cleanliness and regular inspection of the belts and wiring would help maintain optimal performance. Overall, the engine bay looks solid and ready for continued use.

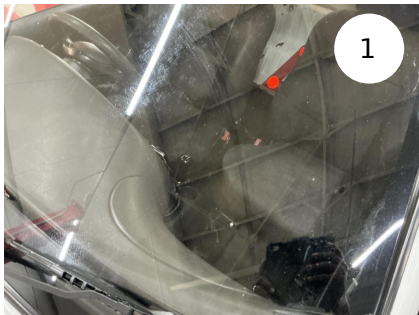
The vehicle's exterior shows some minor cosmetic issues, such as visible dents and scratches on the body panels, which may require attention. All lighting components, including headlights, indicators, brake lights, and reflectors, are in good condition and fully operational. The windscreen and window rubbers are in acceptable condition, with no major cracks or leaks. Mechanical components like door hinges, tailgate, and crumple zones appear structurally sound. Overall, the vehicle has a solid exterior with some cosmetic imperfections that could be addressed for improved appearance and functionality.

| Component | Current Condition | Explanation | Roadworthy Relevant |
|---|---|---|---|
| Body Panels | Below Average | Panels have visible dents, scratches, or previous minor repair work. | |

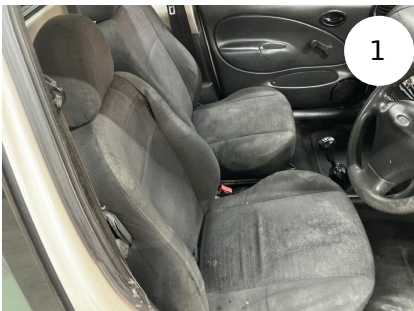
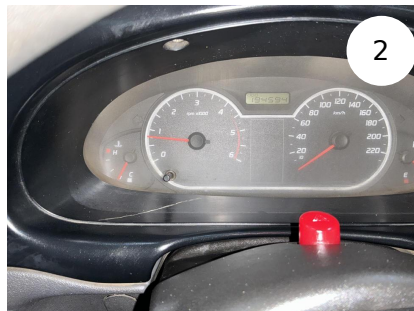
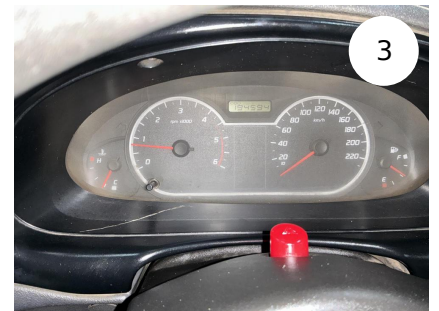
The vehicle's interior features a well-maintained instrument cluster, functional lighting, and reliable locking and safety systems. The seats, however, are in poor condition and will need repair or reupholstery. All pedals, sun visors, and seatbelts are in good working order, contributing to safety and comfort. The windscreen washer system functions but may require attention for optimal performance. Overall, the interior is clean and functional, with some areas needing repairs to ensure a comfortable and safe driving experience.

| Component | Current Condition | Explanation | Roadworthy Relevant |
|---|---|---|---|
| Seats (Condition and | Poor | Seats are torn, broken, or non-adjustable. Repair or reupholstery required. | |

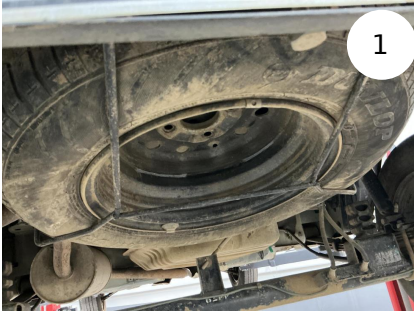
The vehicle's wheels are in good condition overall, with clean and undamaged rims free from curb rash or warping. All wheel nuts are present, tight, and show no signs of tampering. However, the tyres on the front right, rear left, and rear right are in poor condition, being bald, cracked, or damaged, which requires immediate replacement for roadworthiness. The spare wheel well appears intact. Addressing the tyre issues will help ensure safer driving and better vehicle performance.

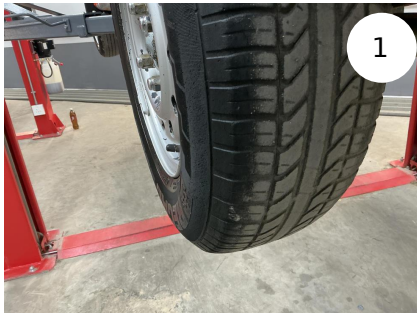
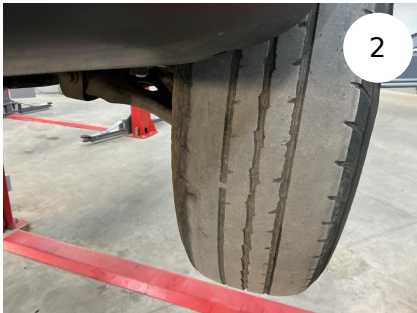
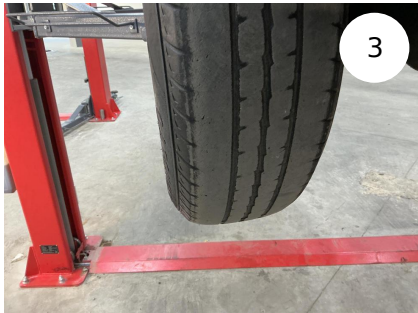
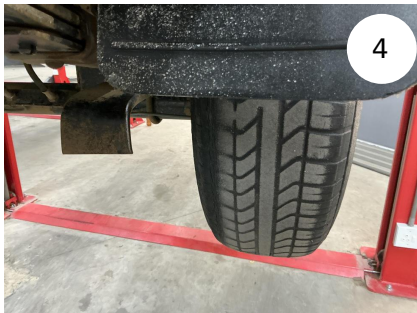
The vehicle's tyres are generally in acceptable condition, with the rear tyres showing a tread depth of 1mm, which is just above the minimum roadworthy limit of 1mm. However, the front tyres have a tread depth of 0mm, indicating they are worn out and not suitable for safe driving. It is advisable to replace the front tyres soon to ensure safety and optimal performance. The spare tyre has a good tread depth of 4mm, ready for use if needed.

| | Size | Load/Speed Index | Make | Model | Type | Tread Depth (mm) |
|---|---|---|---|---|---|---|
| Front Left | 165/80R13 | 83T | Lanvigator | Gp100 | V | 0 |
| Front Right | 165/80R13 | 83T | Lanvigator | Gp200 | V | 0 |
| Rear Left | 165/80R13 | 83T | Regal | Rst 300 | V | 1 |
| Rear Right | 165/80R13 | 83T | Regal | Rst 300 | V | 1 |
