## Assignment

| Client | We Buy Cars |

| Vehicle Type | PASSENGER VEHICLE | Registration Number | 21E400625 |
| Manufacturer | KIA | | |

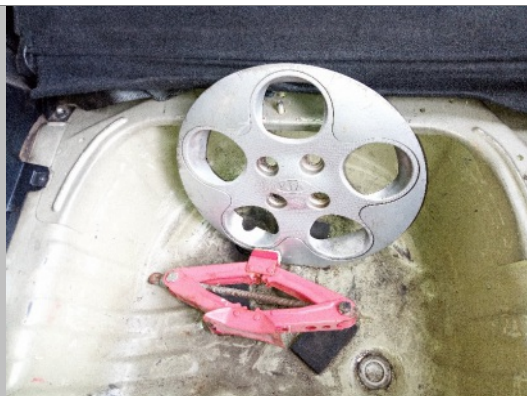
SPARE WHEEL MISSING

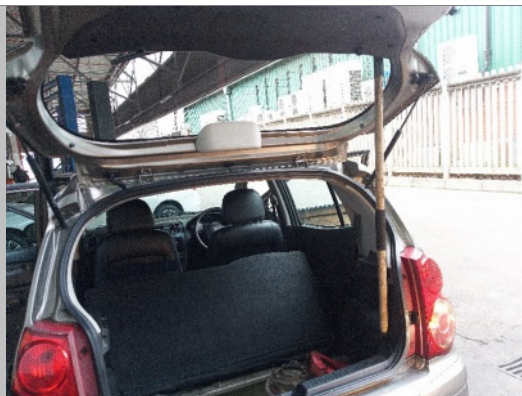
| Damage | Repair Way |
|---|---|
| Tailgate Shocks Defective | Roadworthy Relevant |

TAILGATE SHOCKS DEFECTIVE

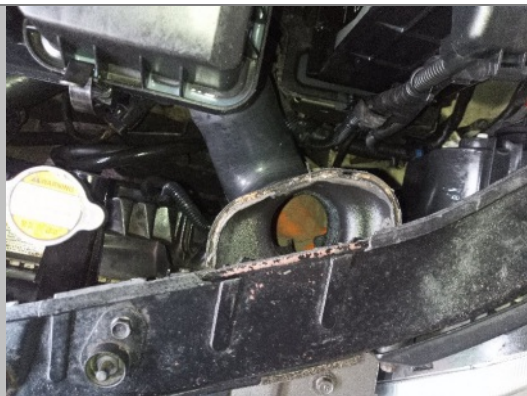
| Damage | Repair Way |
|---|---|
| Air Induction Pipe Cover Missing | Roadworthy Relevant |

AIR INDUCTION PIPE HOUSING MIS

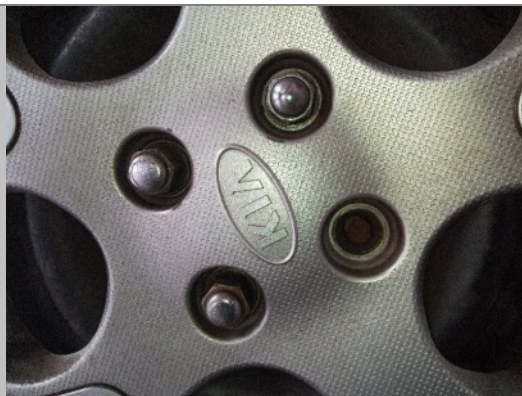
| Damage | Repair Way |
|---|---|
| Right Front Wheel Stud Damaged | Roadworthy Relevant |

RIGHT FRONT WHEEL STUD DAMAGED

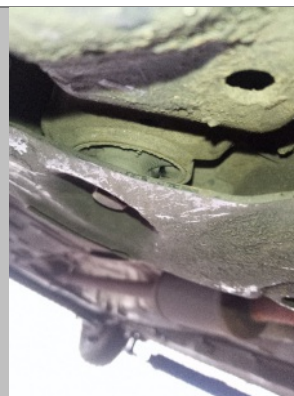
RIGHT FRONT LOWER CONTROL ARM

| Damage | Repair Way |
|---|---|
| Right Front Lower Control Arm Bushes Worn | Roadworthy Relevant |

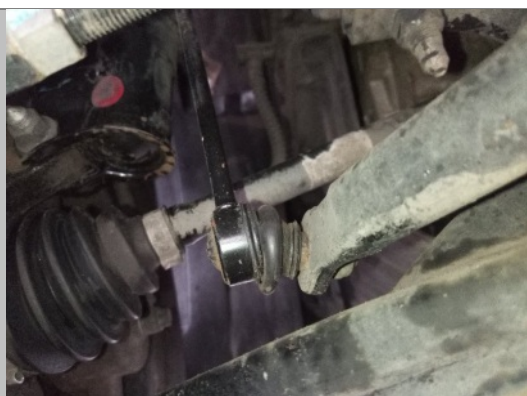
LEFT FRONT LINK ROD DUST COVER

| Damage | Repair Way |
|---|---|
| Left Front Link Rod Dust Cover Damaged | Roadworthy Relevant |

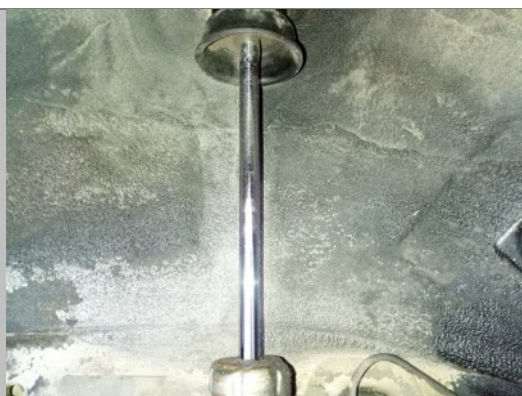
| Damage | Repair Way |
|---|---|
| Both Rear Rebound Rubbers Missing | Roadworthy Relevant |

RIGHT REAR REBOUND RUBBER MISS

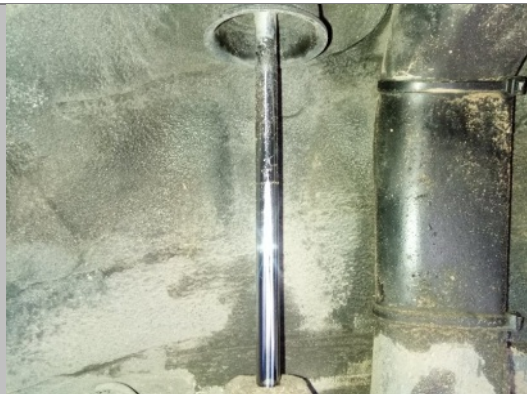
LEFT REAR REBOUND RUBBER MISSI

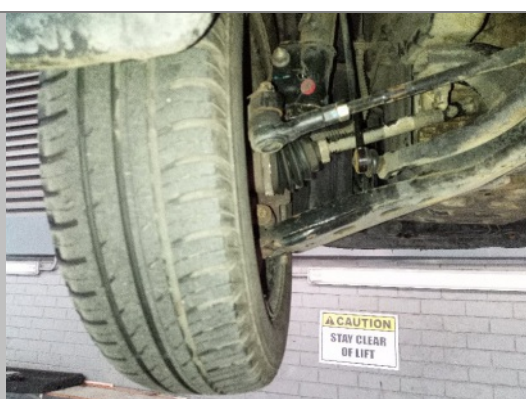
LF TYRE TREAD

| | Size | Load/Speed Index | Manufacture | Model | Type* | Production Date | Tread Depth (mm) |
|---|---|---|---|---|---|---|---|
| Front Left | 155/65R14 | 75T | CONTINENTAL | CONTIECOCONT | V | 3716 | 1 mm |

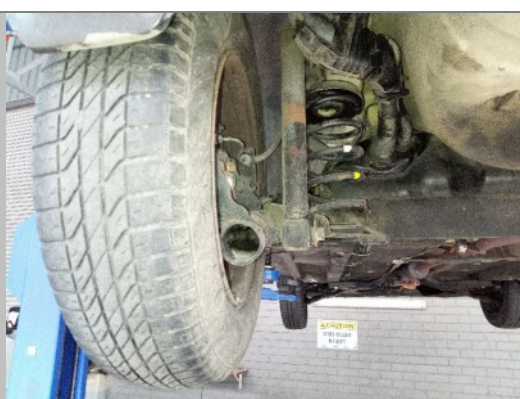
LR TYRE TREAD

| | Size | Load/Speed Index | Manufacture | Model | Type* | Production Date | Tread Depth (mm) |
|---|---|---|---|---|---|---|---|
| Rear Left | 155/80R13 | 79T | DUNLOP | SP SPORT | V | 2816 | 0 mm |

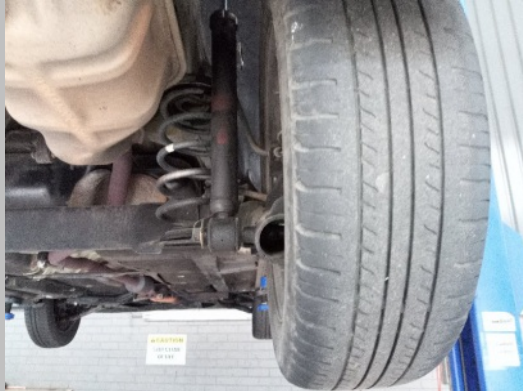
RR TYRE TREAD

| | Size | Load/Speed Index | Manufacture | Model | Type* | Production Date | Tread Depth (mm) |
|---|---|---|---|---|---|---|---|
| Rear Right | 165/60R14 | 75H | TRIANGLE | CNTT | V | 4615 | 0 mm |

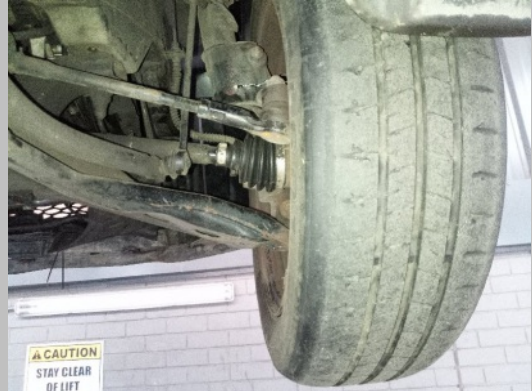
RF TYRE TREAD

| | Size | Load/Speed Index | Manufacture | Model | Type* | Production Date | Tread Depth (mm) |
|---|---|---|---|---|---|---|---|
| Front Right | 165/60R14 | 75H | XCENT | EL601 | V | 4421 | 0 mm |
