## Inspectify Condition Report

| Vehicle Type: | Vehicles | Stock Number: | 74A901123 |
| Manufacturer: | Opel | Transmission: | Manual |
| Model: | Corsa | Doors: | 3 |

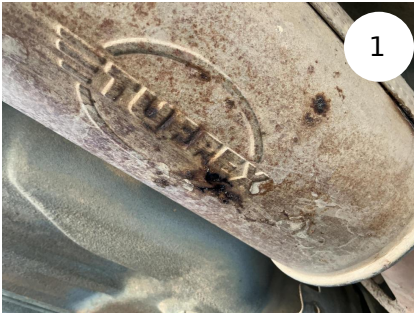
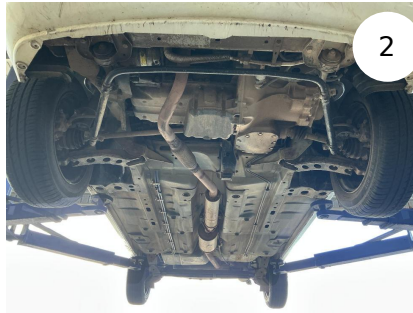
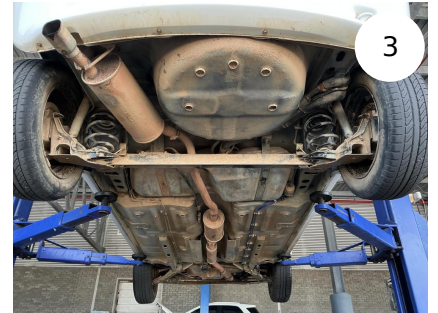
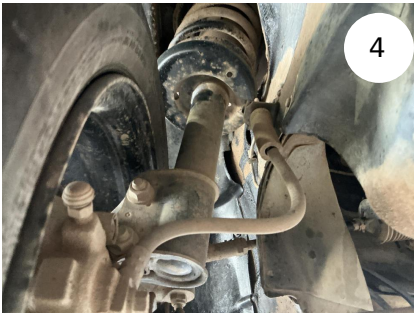
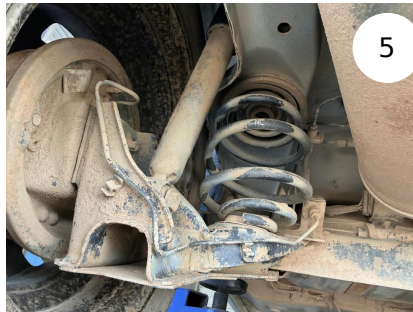
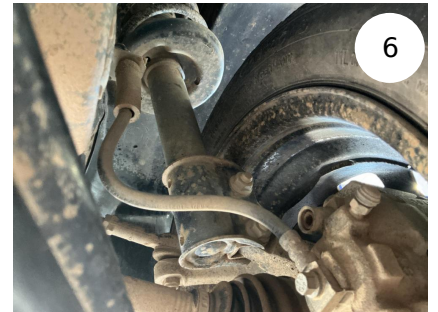
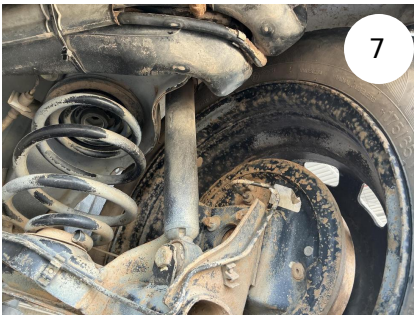
The vehicle's drive system appears generally sound, with most components in acceptable condition for its age. The suspension, axles, steering, and gearbox are functioning normally, and the cooling system is in good shape. However, the exhaust system is broken and leaking significantly, which requires urgent repair. Additionally, minor aging is visible in coolant hoses and connections, and the exhaust system needs fixing to ensure optimal performance and safety. Overall, with some attention to the exhaust, the drive system can be reliable.

| Component | Current Condition | Explanation | Roadworthy Relevant |
|---|---|---|---|
| Exhaust system | Poor | Exhaust system is broken, leaking significantly, or noisy. Requires urgent attention. | X |

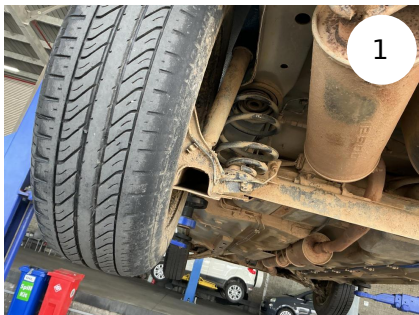
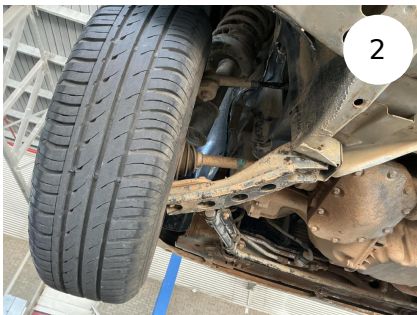
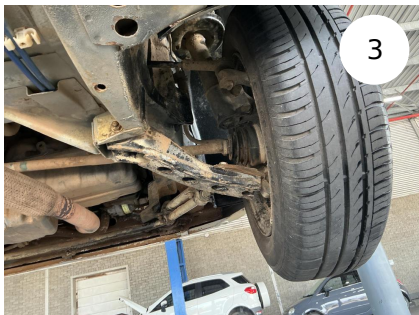
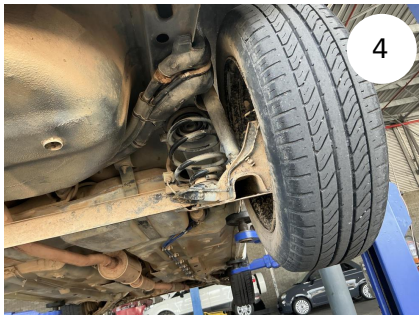
The vehicle's front tyres have a tread depth of 5mm, which is good for safe driving. However, the rear tyres show a tread depth of 0mm and 2mm, meaning they are below the legal limit of 1mm and are not roadworthy. It is recommended to replace the rear tyres soon to ensure safety. The tyres are of good make and size, but attention to the rear tyres will improve overall safety and performance.

| | Size | Load/Speed Index | Make | Model | Type | Tread Depth (mm) |
|---|---|---|---|---|---|---|
| Rear Left | 175/65R14 | 82T | Dunlop | Sport | V | 0 |
| Rear Right | 175/65R14 | 82T | Dunlop | Sport | V | 2 |
