## Assignment

| Client | We Buy Cars |

| Vehicle Type | PASSENGER VEHICLE | Registration Number | C8E714314 |
| Manufacturer | TOYOTA | | |

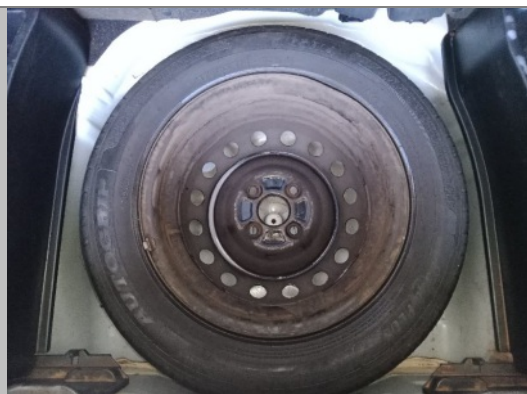
Spare wheel.

| Components | Condition | Inspection Result |
|---|---|---|
| Spare wheel | Poor | The spare wheel tread depth is below 1mm, damaged or missing and must be replaced. |

| | Size | Load/Speed Index | Manufacture | Model | Type* | Production Date | Tread Depth (mm) |
|---|---|---|---|---|---|---|---|
| Spare | 175/65R14 | 82H | Autogrip | P308 | V | 0000 | 0 mm |

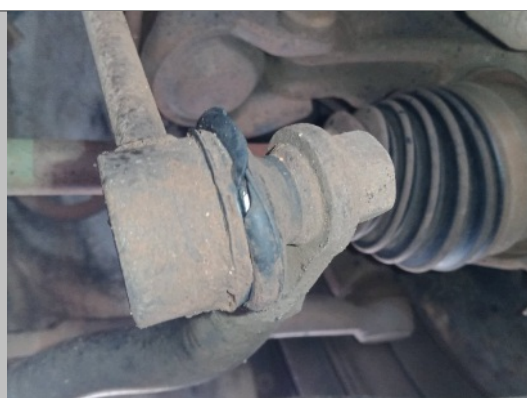
| Components | Condition | Inspection Result |
|---|---|---|
| Axles , Suspension | Poor | Axles and / or suspension show damages that affect the safety of the vehicle and will need repairs to be deemed safe for future use. |

| Damage | Repair Way |
|---|---|
| Left front stabilizer link dust cover torn. | Roadworthy relevant. |

Left front stabilizer link dust

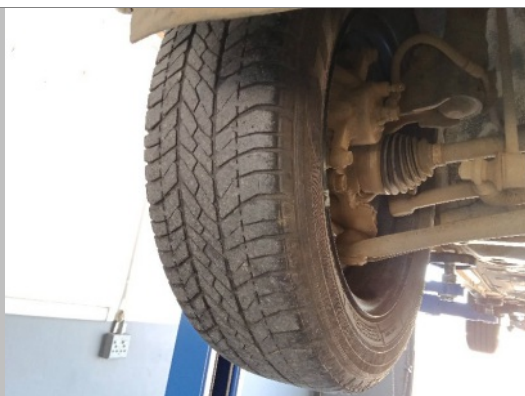
RF TYRE TREAD

| | Size | Load/Speed Index | Manufacture | Model | Type* | Production Date | Tread Depth (mm) |
|---|---|---|---|---|---|---|---|
| Front Right | 175/65R14 | 82T | Goodyear | GT2 | V | 3913 | 2 mm |

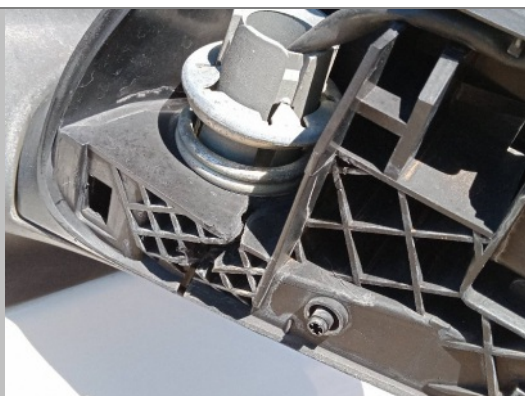
| Components | Condition | Inspection Result |
|---|---|---|
| Hang-on parts (grill, bumpers, mirrors, antennas, strips, etc.) | Poor | Hang-on parts (grill, bumpers, mirrors, antennas, strips, etc.) with major damages and/or missing. |

| Damage | Repair Way |
|---|---|
| Side Mirror Left Broken | Roadworthy Relevant |

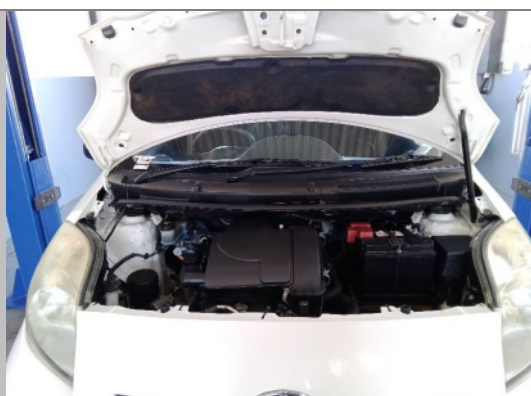
| Components | Condition | Inspection Result |
|---|---|---|
| Mechanical function of doors / bonnet / tailgate | Poor | Defects were detected on mechanics of doors, lids, bonnet. The mechanics of doors, lids, bonnet may need to be repaired or replaced. |

| Damage | Repair Way |
|---|---|
| Bonnet stay and shocks Missing | Roadworthy Relevant |

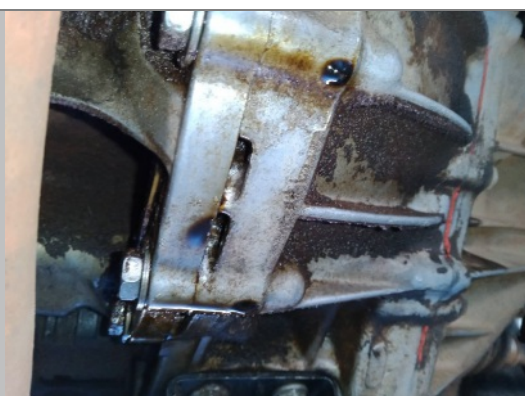
| Components | Condition | Inspection Result |
|---|---|---|
| Oil loss engine | Poor | The engine is leaking oil and needs mechanical intervention or repair. |

| Damage | Repair Way |
|---|---|
| Engine Oil Leak | Roadworthy Relevant |
