## Assignment

| Client | We Buy Cars |

| Vehicle Type | PASSENGER VEHICLE | Registration Number | 21E400625 |
| Manufacturer | KIA | | |

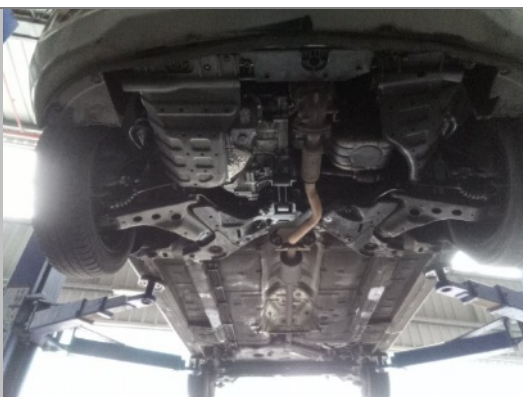
CHASSIS

| Components | Condition | Inspection Result |
|---|---|---|
| Vehicle undercarriage | Poor | The undercarriage has major impact and/ or corrosion damages and/or signs of non-quality repair. The undercarriage need to be repaired to be deemed safe for future use. |
