## Assignment

| Client | We Buy Cars |

| Vehicle Type | PASSENGER VEHICLE | Registration Number | C8E714314 |
| Manufacturer | TOYOTA | | |

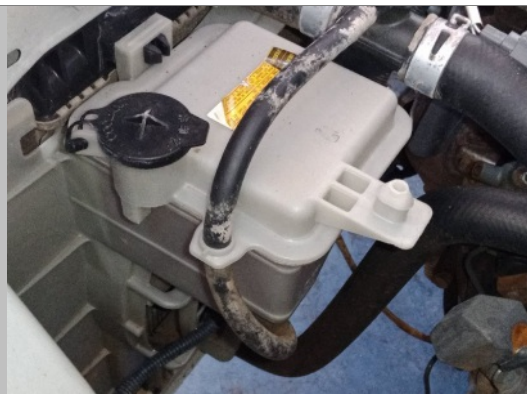
| Components | Condition | Inspection Result |
|---|---|---|
| Engine Cooling System | Very Good | The cooling system is without testable defects. The coolant level is normal. |

Coolant level.

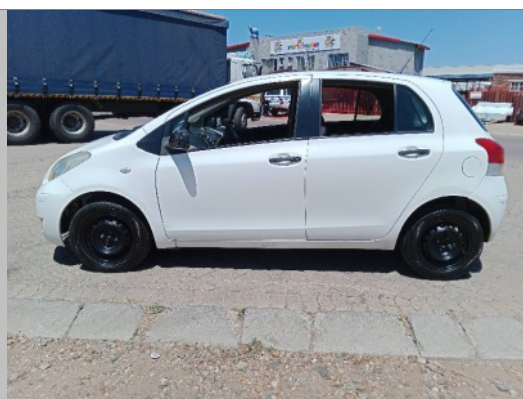
90 DEGREE LEFT

| Damage | Repair Way |
|---|---|
| Side Mirror Left Broken | Roadworthy Relevant |
